# Manhole Inspection Summary

Manhole # S27S\_\_012MH

Insp Date: **4/29/08 10:09 AM**

**Location** Address: **1600 Wicomico st corner**

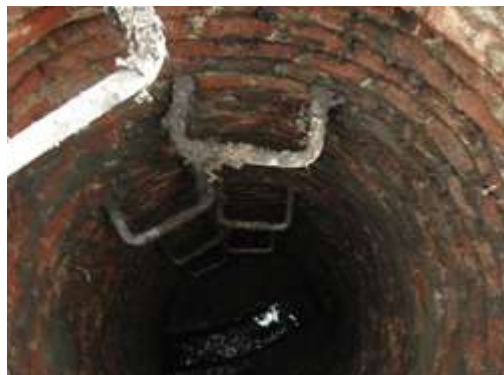
Defect 4

**Steps** Count: **7** Missing: **0** ☒ **Corroded**

**Surcharge** ☒ **Evidence Of Surcharge** Depth: **9.5** (ft.) ☐ Active Surcharge Present

rusted rungs and surcharge evidence

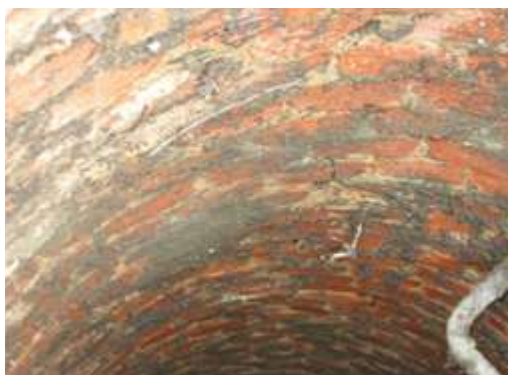
Defect 8

Infiltration: ☐ None ☐ Joint ☐ Cracks ☐ Mortar ☐ Roots ☒ **Wall**

chimney/corbel infiltration

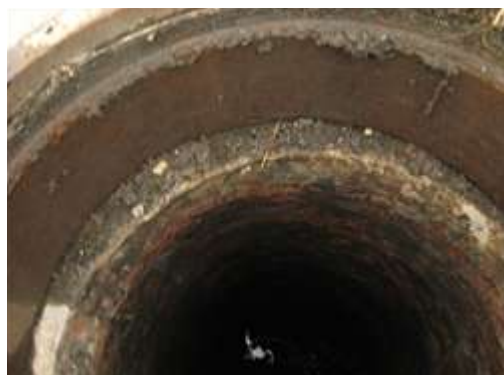
Defect 3

**Frame** Offset: **2** (in.) Condition: ☐ Sound ☐ Cracked ☒ **Leaks**

offset frame

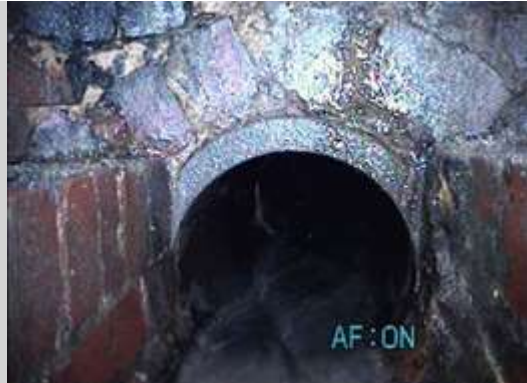
12 O'Clock Outflow

signs of infiltration top right

Pipe Height: **10.8** (in.) Rod and Bar (Angled)  
Pipe Material: **Clay** ☐ Pipe Lined  
Invert Depth: **13.60** (ft.) Flow Characteristics: **Fast**  
Deposits: ☒ None ☐ Mud ☐ Sludge ☐ Debris ☐ Grease  
Silt Depth: **0** (in.) Deposits Extent:  
Infiltration: **Evidence** Pipe Seal Cond: **Unknown**

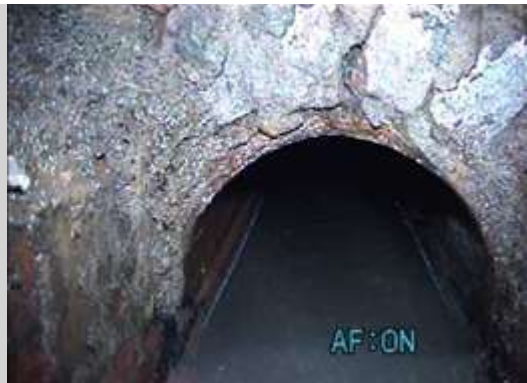
5 O'Clock Inflow

Pipe Height: **10.8** (in.) Rod and Bar (Angled)  
Pipe Material: **Clay** ☐ Pipe Lined  
Invert Depth: **13.56** (ft.) Flow Characteristics: **Fast**  
Deposits: ☒ None ☐ Mud ☐ Sludge ☐ Debris ☐ Grease  
Silt Depth: **0** (in.) Deposits Extent:  
Infiltration: **Evidence** Pipe Seal Cond: **Unknown**
